Service Bulletin

Bulletin No.: 20-NA-197

Subject: Malfunction Indicator Lamp (MIL) Illuminated - DTC P0087, P0089, P0191, P026C, P026D, P1089, P163A, P163B, P2293, P228A, P228B, P228C, and/or P228D

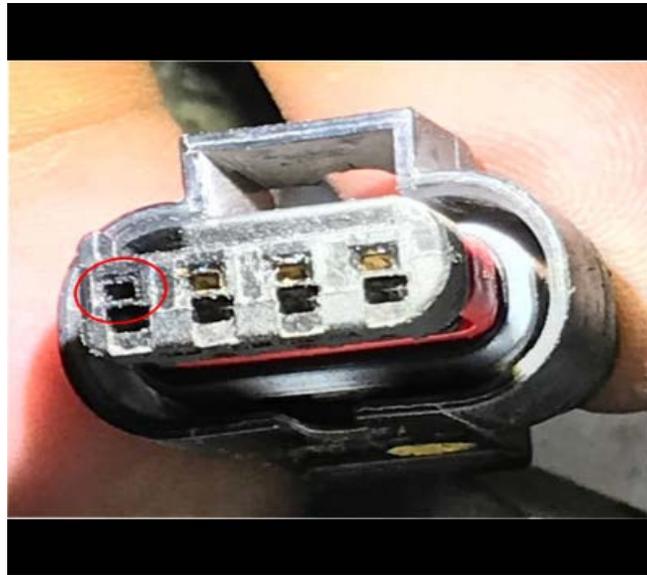
5652222

Cause	This condition may be caused by corrosion or damaged at the fuel pressure sensor electrical connector.

Inspect the fuel pressure sensor electrical connector for corrosion or damage.

⇒ It may be necessary to use the terminal test kit with dielectric grease on it and apply/drag each terminal a few times.
